THE CLUTCH - HOW IT WORKS AND HOW TO KEEP IT WORKING.

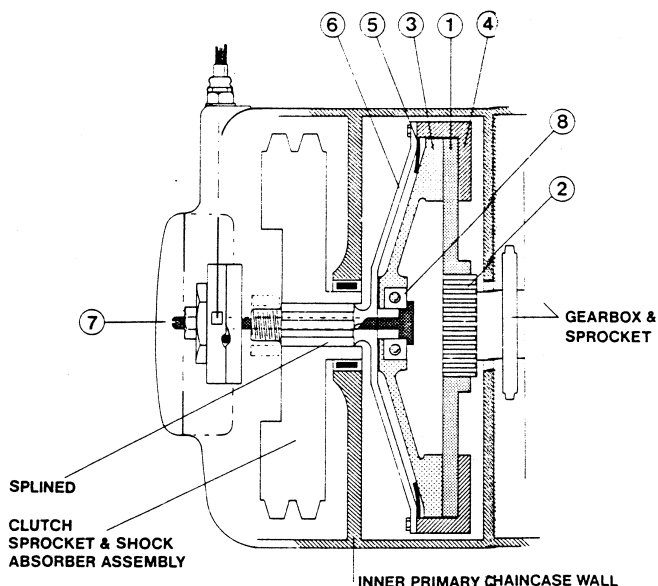
Referring to the main diagram;

1 is the DRIVEN plate. It is made of friction material and is toothed on the inside diameter. These teeth are in permanent engagement with the clutch hub, 2.

3 is the DRIVE plate. It has lugs which slide in slots in the clutch drum sides (4).

5 is the diaphragm spring. 6 is the end cover, which holds the two plates and the spring together under pressure. It is secured to the drum by twelve bolts around the outer edge.

To disengage the clutch it can be seen that the drive plate has to be pulled away from the driven plate against the pressure of the spring. This is done by the pull-rod and ball-and-ramp mechanism. The pull rod, 7, bears against the centre of the drive plate; as the rod is static and the plate is moving, a bearing (8) is essential. This bearing relies on grease packed during its construction for lubrication.

The pull rod passes through a tunnel in the clutch cover shaft, through the clutch sprocket assembly, through the ball-and-ramp mechanism and into a threaded nut (9) which is secured by a locknut (10). See sketches A and B.

11 is fixed into the outer chaincase wall, 12 is moveable. Three ball bearings are sandwiched between the two. When you pull on the cable which is connected to the arm on 12, you therefore pull 12 anti-clockwise. By comparing sketches A and B you can see what happens. In A, the clutch is engaged and the pull-rod is slack. The gap between the nut 9 and the side of 12 represents the clearance gap; the owner's hand-book says 5 thou but experience has shown that this is too much. A better method of adjustment is described later on.

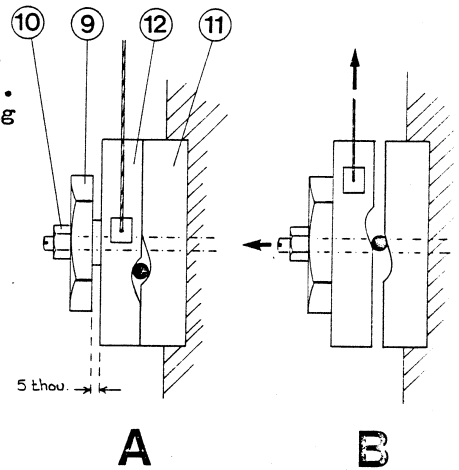
In sketch B the cable has been pulled, and this has rotated the outer half of the unit (12) anti-clockwise. This forces the balls up their ramps which in turn pushes 12 outwards until it contacts the nut 9. As this action continues, the nut, and therefore the pull rod, is forced outwards. The rod contacts the drive plate and the clutch is then freed.

Obviously a clearance here is vital, as it is your guarantee that the fast-moving bearing is not being held tight against the static rod. The rod must only make contact with the bearing during the time the clutch is actually being disengaged.

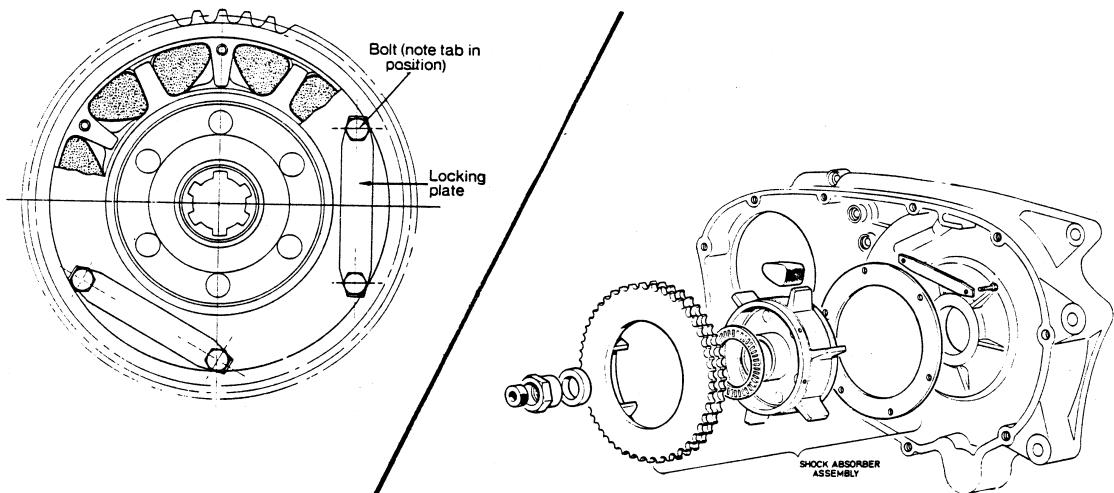
Shock absorber unit

A look at the sketch below will show how the unit fits together. A T160 is shown but all models are similar in principle. The very early triples have a different type of rubber and cover as explained later.

A set of s/a rubbers should last a minimum of 15,000 miles; premature failure is due entirely to poor manufacture of the unit. It is in two halves, an inner 'spider' and the outer part combined with the sprocket. Each half has six vanes, and the two halves mesh together with a rubber between each vane. The fault lies in the clearance between the tips of each vane and the opposing halves body; there should be a maximum gap of around 20 thou (minimum 5 thou). Unfortunately triples of all ages, especially T160's, have suffered from poor construction and clearance gaps of over treble the maximum have been recorded. The result of this is that the rubbers, under constant compression and load, are literally squeezed through the gaps. As the vanes have sharp edges the rubbers are rapidly cut to pieces.

The cure is simple - build up the vanes with weld and file to the appropriate clearance.
